"Solar Array Flight Experiment

# Final Report

Contract NAS-8-31352

April 1986

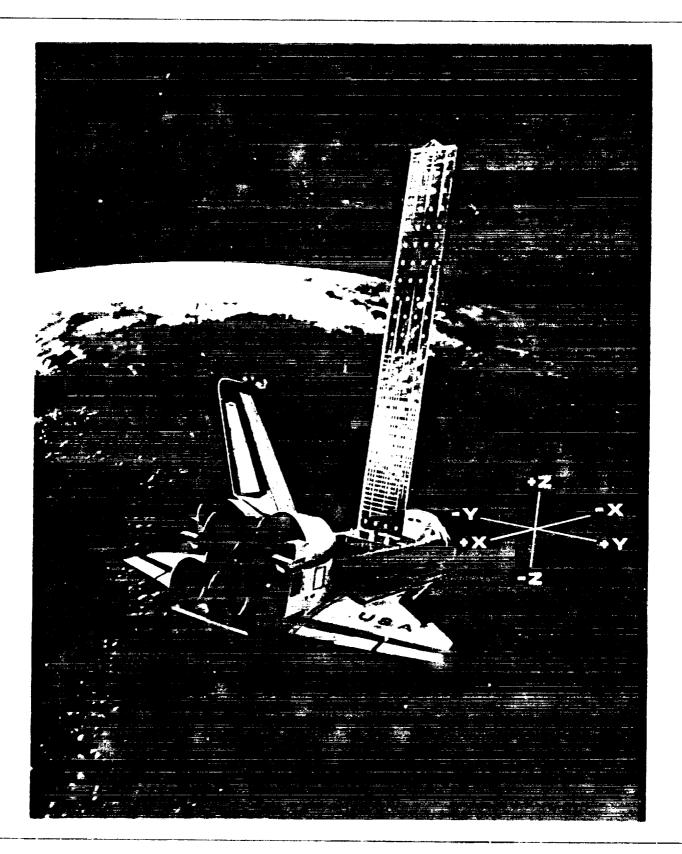
Fig. 1-1 Axis System Used for Final Report

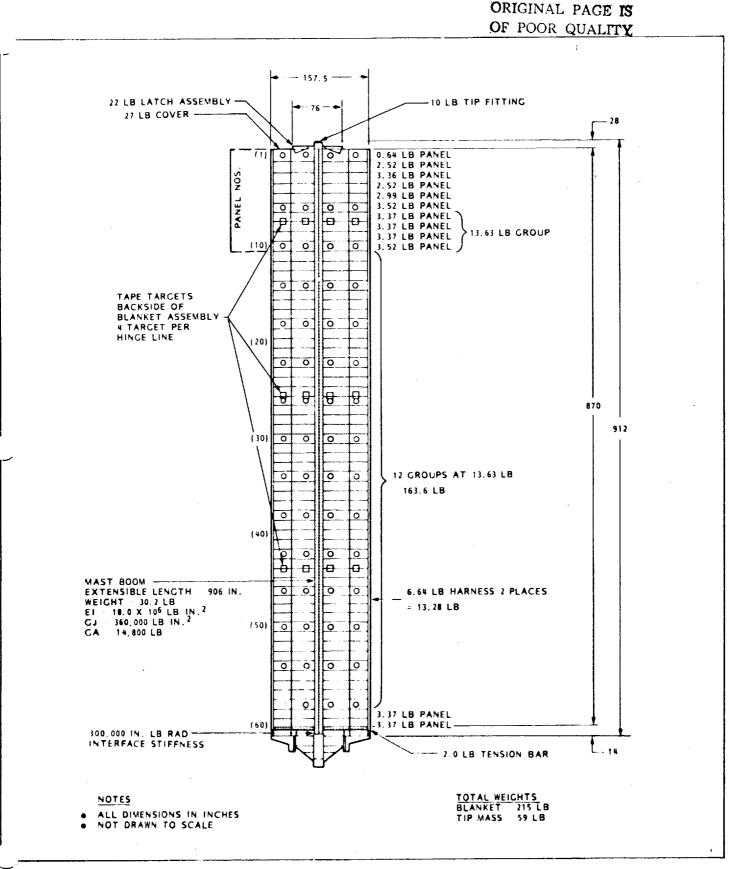
Fig. 1-4 Dimensions of the Array at 70-Percent-Extended Position

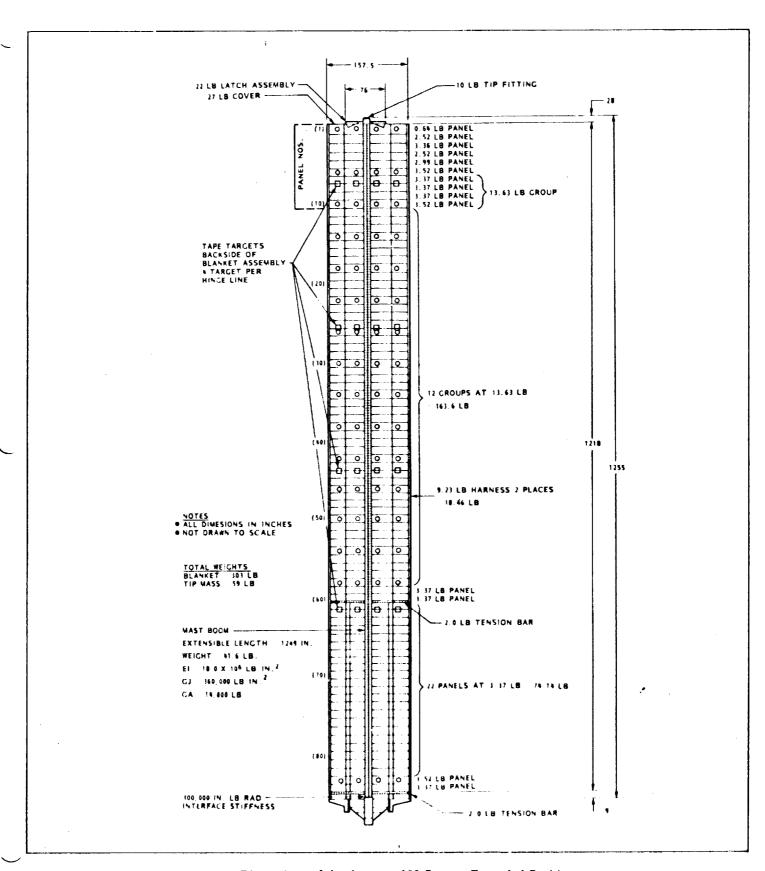
Fig. 1-5 Dimensions of the Array at 100-Percent-Extended Position

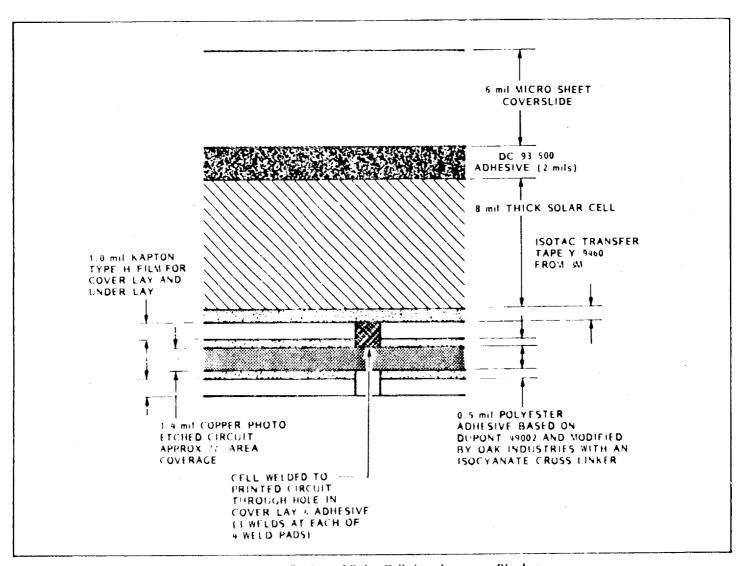
Fig. 1-6 Cross Section of Solar Cell Attachment to Blanket

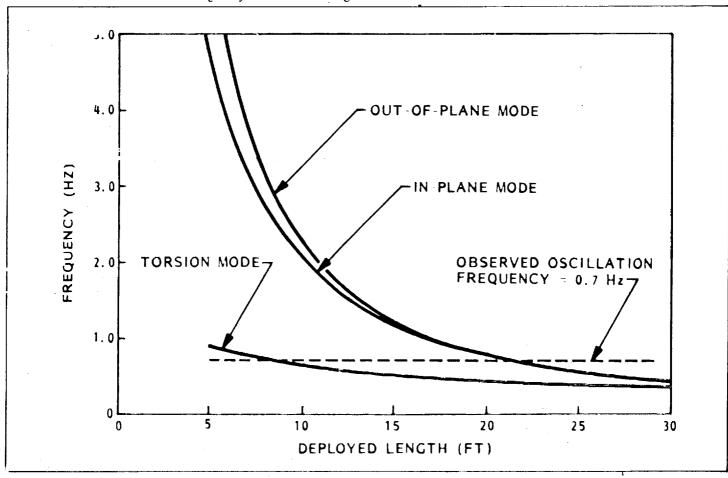
Fig. 2-1 Mast Frequencies During Final Position of Retraction Event

To further understand the oscillation, the frequency of the first three modes of the partially deployed mast were computed by ignoring the mass of the deployed mast and blanket. This computation results in a model that is basically a massless beam with the tip mass and inertia of the containment box cover. The results of this evaluation are shown in Fig. 2-1. As seen in this figure, both the in-plane and out-of-plane modes have frequencies near the observed oscillation

The most likely source of the disturbance causing the observed oscillation is the motion of the rotating nut assembly. One might expect the frequency at which the longeron rollers exit the rotating nut to match the frequency of oscillation. This match seems likely since a very small amount of mast deformation accompanies the release of a longeron roller. However, this disturbance frequency is 0.17 hertz, and, therefore, not close to the frequency of the observed oscillation. Since it takes four turns of the rotating nut to release each set of longeron rollers, the rotational frequency of the rotating nut is 0.68 hertz, which matches closely the frequency of the observed oscillation. Thus, the panel oscillation seems to be caused by a resonance, occurring during the last 20 feet of retraction, between the rotational frequency of the rotating nut and the cantilevered mast modes. The disturbances in the mast excited the several most outboard panels of the array causing the observed panel oscillation.

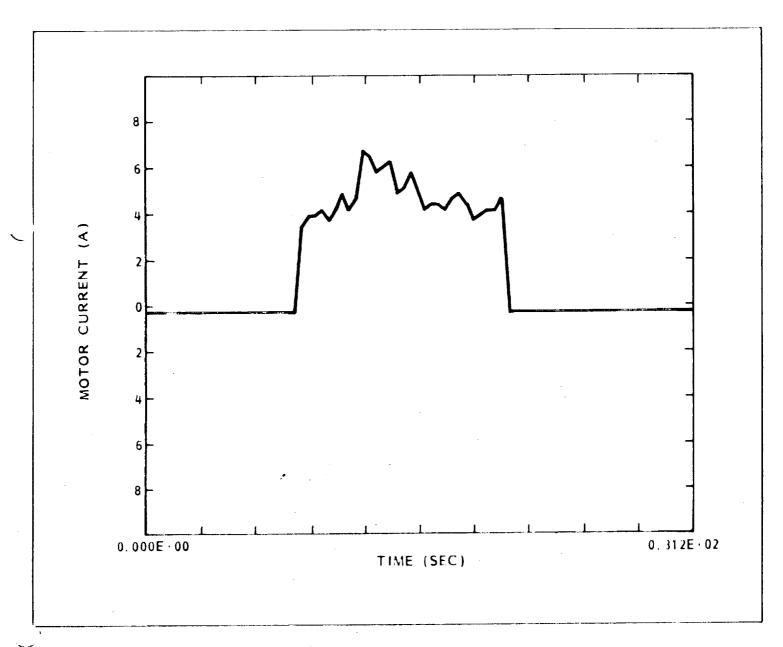
Fig. 2-2 Motor Current Usage During Mast Nut Unlock (Event 1)

shown in Fig. 2-2 and 2-3, respectively. For these two events, the current usage during flight and that during ground test match closely. For the remainder of the extensions and retractions, the current usage in flight is slightly higher than in ground test. The most likely cause for the current increase relative to ground tests is the higher operating voltage, as discussed in the previous paragraph. Also, the blanket tension loads are reacted differently in flight than in ground test. In flight, the moment in the mast due to the offset tension loads causes the mast to bend and produces reaction loads on the longeron pivot fittings where the mast enters the canister. These loads increase the motor current required to drive the

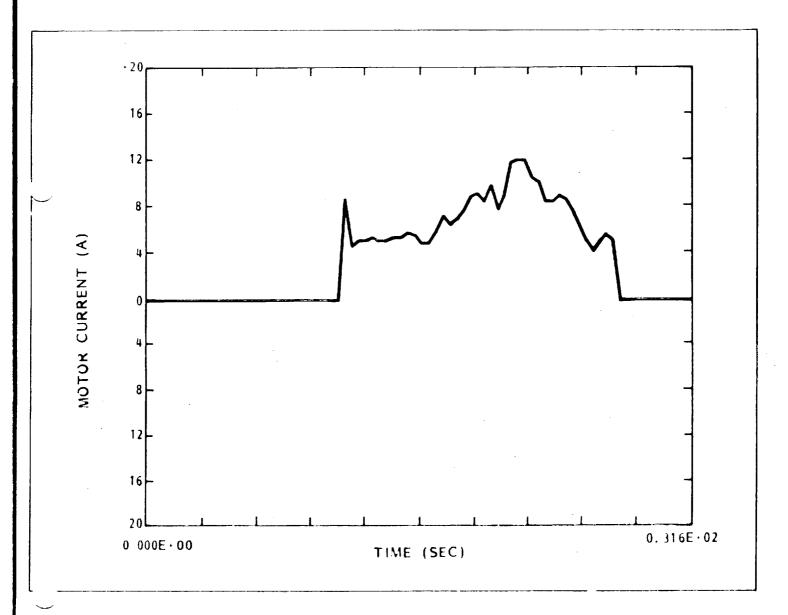
Fig. 2-3 Motor Current Usage During Mast Hard Retract (Event 31)

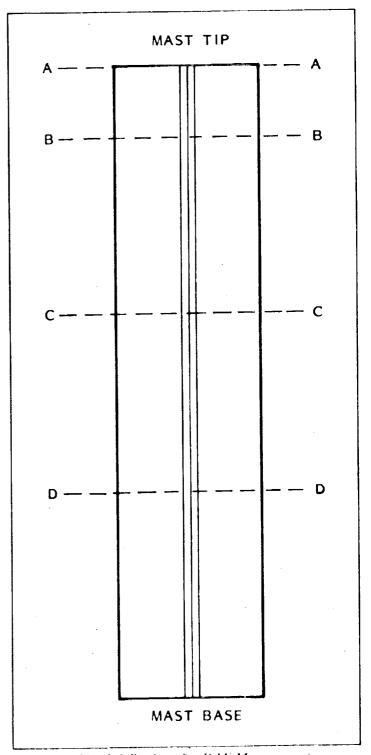
Fig. 2-4 Stations for DAF Measurements

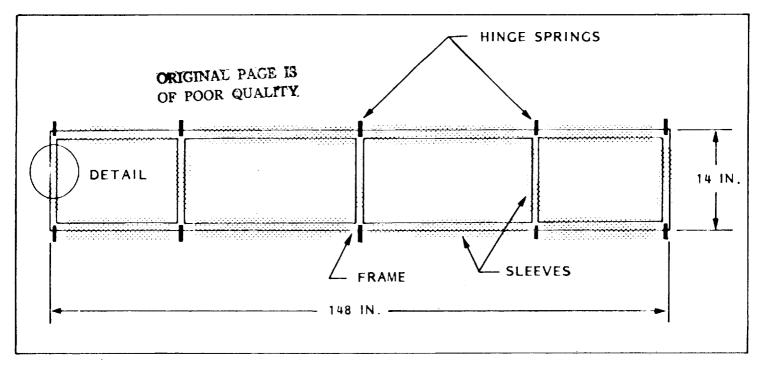
Fig. 2-8 Sleeve Construction for Panel Frames

Loss of Clearance Between Aluminum Frame Members and Kapton Sleeves. Investigation of the panel curvature has revealed a number of reasons to suggest that its probable cause was loss of the nominal 0.050-inch gap between the aluminum frames and Kapton sleeves.

Finally, the 0.050-inch gap between the aluminum frames and Kapton sleeves may have been inadequate because of the difficulty in maintaining this tolerance over a 13.5-foot span with bonded construction techniques. Any tension in the panel at the time of bonding or any misalignment in the sleeve segments would effectively reduce the intended gap at one location or another.

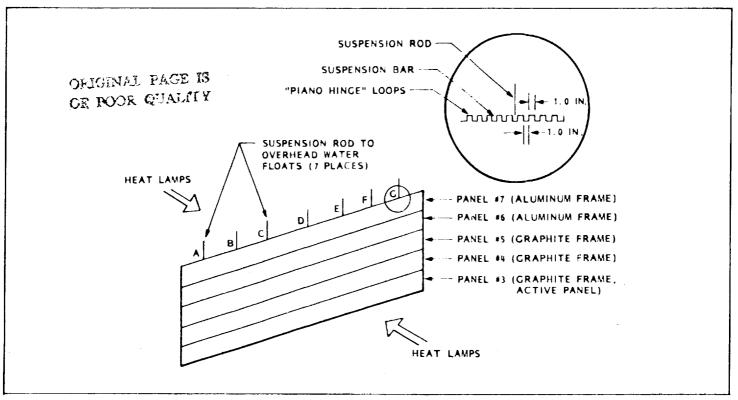
Fig. 2-10 Panel Curvature Test Method

Panel Curvature Test. A panel-curvature test was performed on flight panels 3 through 7 (as measured from the array tip) by removing the panels from the blanket after the postflight extension and retraction tests. Panels 3, 4, and 5 have graphite epoxy frames, and panels 6 and 7 have aluminum frames. The panels were oriented in a test fixture as shown in Fig. 2-10. By selecting five panels, the panel weight produced a tension at the upper hinge line nearly equal to the uniform flight tension. Because the tests were to be exploratory, they were performed in room ambient conditions where test variables could be easily changed. The intent of the tests was not necessarily to reproduce the magnitude of flight curvature but to produce some curvature and to determine the source of it. Radiant lamps were used to heat the panels from the cell side, from the back side, or from both sides simultaneously. The lamps could be raised or lowered so that the heat could be directed at the panels with aluminum frames or at the panels with graphite epoxy frames. The frame temperatures were monitored with thermocouples, and the upper temperature limit was chosen as 176°F. This is the maximum solar cell temperature observed during the flight.

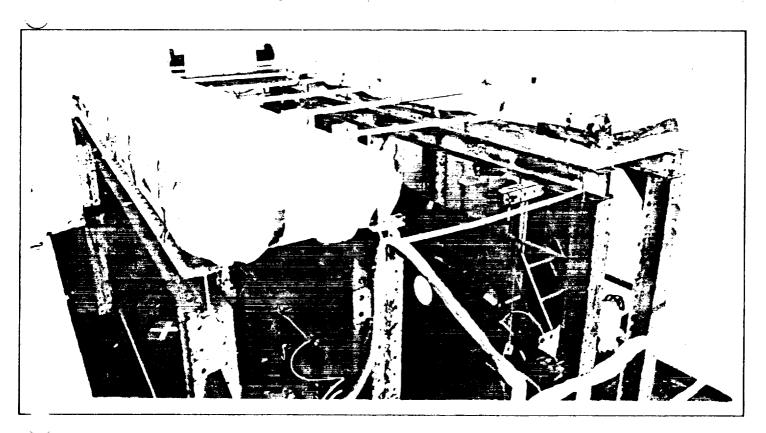
Fig. 2-11 Water Tanks and Float System for Panel Curvature Test

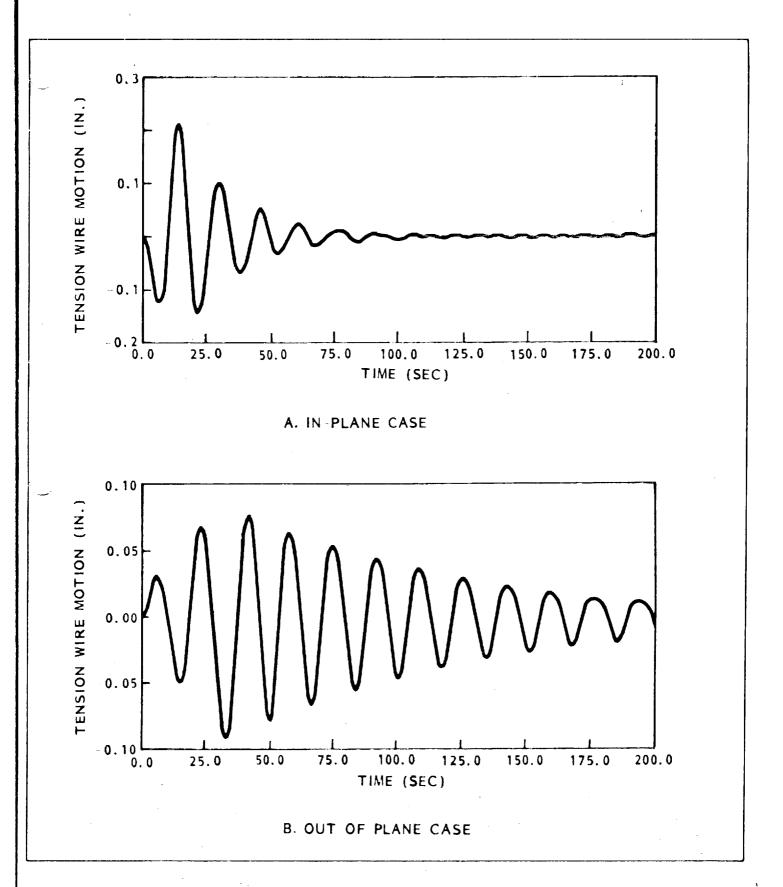
Fig. 2-24 Comparison of Tension Wire Motion for an In-Plane and Out-of-Plane Test
